### CHALLENGE

Needed to extend service life and eliminate repeated packing leaks that could lead to disastrous fire events caused by hydrogen leakage.

### SOLUTION

MOGAS ball valves installed with a heavy-duty mounting bracket to support heavy actuators and reduce risk of damaging side loads to stem.

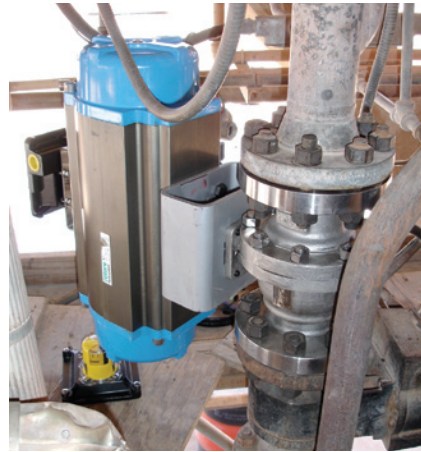
*This MOGAS valve – with a sturdy mounting bracket, spring-loaded packing along with proper stem bushing alignment – provided a record 25,000 cycles, greatly improving runtime.*

These malfunctioning valves were replaced with MOGAS severe service ball valves. By using thermal spray and fuse coatings and a wide seat design, the MOGAS replacement valves provide exceptional performance under the difficult conditions associated with the CCR process (high temperature, high pressure, catalyst handling, continuous service / high cycle count). Other unique MOGAS valve features include:

#### Live-Loaded Packing Design

- Spring-loaded packing eliminates hydrogen leaks to atmosphere and associated fire risks
- Meets EPA volatile organic compounds (VOC) emission standards

#### Stem Support Bushing

- Secondary stem bearing guide prevents lateral movement and possible packing deformation
- Combines with standard double inner stem seals to provide a dual stem guiding system

#### Sturdy Actuator Mounting Bracket

- Welded or bolted into place and machined
- Centered surface helps maintain proper stem and stem bushing alignment — and extends valve cycle life in the process
